Assessment of a rock planar slide along an expressway in Vietnam

This paper presents an assessment of a rock planar slide, which took place at km 108 along the Tien Yen-Mong Cai expressway, an extension of the Halong-Vandon expressway in Vietnam. Half of the expressway has been covered by a large volume of rock deposit after its movement. The height of the slope in this study is 16 m and its width is 200 m. The main head scarp is about 11 m high. The sliding angle of the failure surface is from 12°-15°. The stratigraphy mostly consists of weathered jointed siltstone, which is located in the upper part of the Ha Coi formation (J₁₋₂hc₂). The sedimentary rocks are thick bedded, fine-grained sandstones interbedded with medium-bedded chocolate pink siltstones or thin-bedded shales. In general, they are medium to thick bedded with the thickness of rock layer from 0.3-0.8 m. The upper rock layer is the 9b-1 layer with RQD = 0-36% whereas the lower one is the 9b-2 layer with RQD = 0-92%. The topsoil layer is 0.5-2.5 m thick. Rockplane and Plaxis computer softwares were adopted to perform stability analysis of the slope. Results showed that the overall factor of safety of the slope before

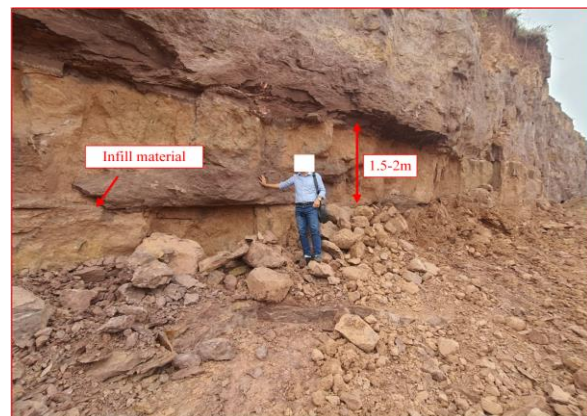
Bedding joints are the major structural features of the rock layer in the site with a dominant orientation (Figure 4). As shown in Figure 5, a thin film of calcite infill could be observed at most of bedding joints, which is attributed to the existence of groundwater in joints causing calcite to precipitate. This infill material with low shear strength will contribute to the sliding of the rock slope. In addition, strong rock layers, including siltstone, fine quartz sandstone, are sandwiched by highly weathered shale layers, which are easily softened under saturated conditions. These thin shale layers could become potential sliding surfaces of the

Figure 4. Interbedded siltstone at the head scarp of slope failure Do et al. (2024).

The rock slide can be classified as a planar sliding type due to its characteristics as shown in Figs. 1, 2, 4, and 5. The study by Hoek and Bray (1981) has addressed the kinematic conditions for a plane mode of failure when the strike difference between the slope face and the potential failure surface is almost parallel ($\pm 20^\circ$). Also, the lateral surfaces on both sides of the sliding block would not provide any resistance against the sliding. A plane failure may occur when a discontinuity dips in a similar direction to the slope surface, which is smaller than the slope angle but greater than the friction angle along the failure plane. There is no side effect to the stability of the slope because the slope surface is convex. The stereographic projection slope section with the dominant bedding planes and the cut slope face is shown in Figure 6. Potential plane failure can be observed in this figure. If it is assumed that the shear strength of the bedding joint is contributed from the friction angle only, the planar failure will take place once the friction angle is lower than the dip angle of bedding planes, i.e., from 12° to 15° .

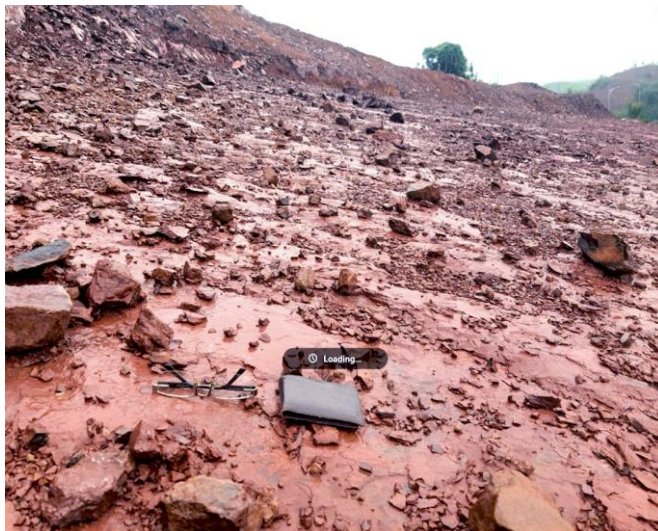
slope (Figure 5). Based on the rock mass quality, two bedrock layers can be characterized, including moderately weathered horizon and slightly weathered horizon ones. There is a residual and colluvium soil layer, which overlays the bedrock. Section 2.3 will describe the characteristics of soil and rock layers in detail.

Figure 5. Smooth sliding surface of the rock layer.

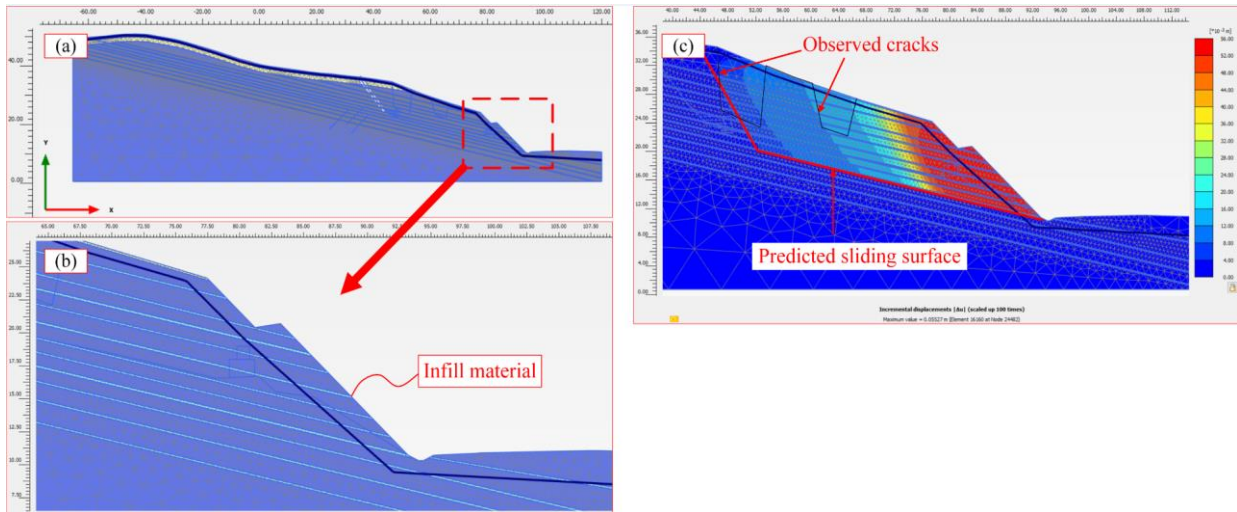
Figure 13a is the numerical model of the slope in Plaxis. As shown in Figure 13b, the infill material was simulated using thin strips, which inclined 13.4° with respect to the horizontal line. It was assumed that these strips ranged throughout the slope. Figures 13c and 14 are total incremental displacement plots of the slope in stability analysis before and after treatment, respectively. It is noted that the location of the groundwater table before treatment was assumed near the ground surface based on the state of soil and rock layers in the site observed by

As using the Plaxis software, the total incremental displacement plot of the slope at the initial state in stability analysis is shown in Figure 13c. Since the total incremental displacement represents the velocity of soil/rock movement at the last calculated step, this displacement will be very large if the slope approaches an unstable state. Based on the development of the total incremental displacement, the sliding surface of the slope could be determined in the figure, which matches well with the distribution of cracks measured in the site. The overall factor of safety estimated by the Plaxis software was 0.69. This result is very close to that of Rockplane and also

Figure 13. Numerical model of cross section 12-12 for the initial rock slope in Plaxis.
